Features

Specification

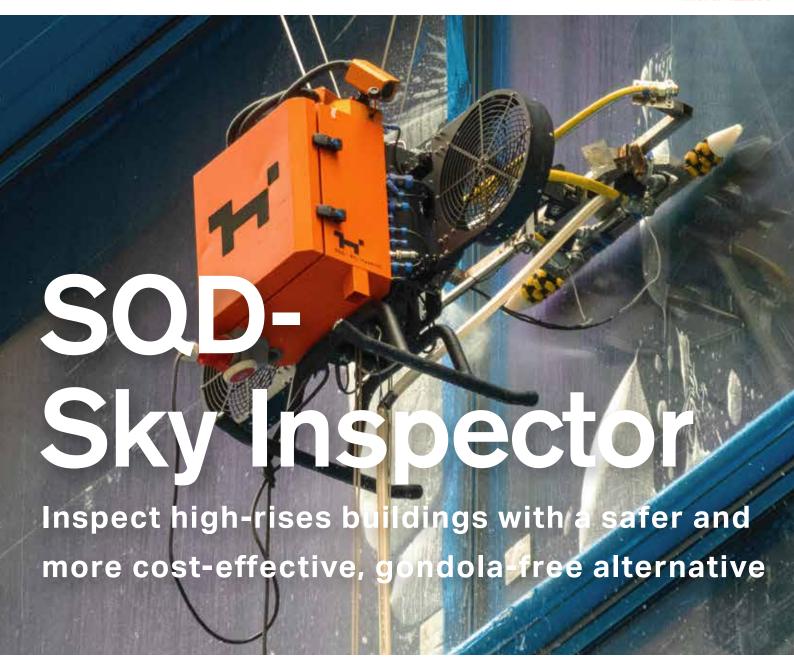
Tools for testing leakage

- AAMA 501 compliance
- 35psi water jet
- 300mm adjustable jet distance

Pair of propellers

- Auto-stabilizing
- Auto-adjusting distance between robot and wall

Dual-wire system

- Stabilizing mechanism
- Robot able to move in all directions

Camera system

- 4 x Live HD wireless cameras

Size	1350 x 950 x 1100 mm
Operating height	180 m
Operating width	30 - 40 m
Net weight	73 kg
Maximum speed	8 metres / min
Rated power	2860 W, 13 A
Input voltage	210 - 230 V
Ingression protection (IP) rating	IP 54
Steel wire specification	Ø4.0 mm / 930 kg bearing load
Fall arrest system	Ø6mm steel wire x 2
Wireless remote control	LoRa
Wireless video transmit frequency	5.8 GHz
Water leaking test standard	AAMA 501.2

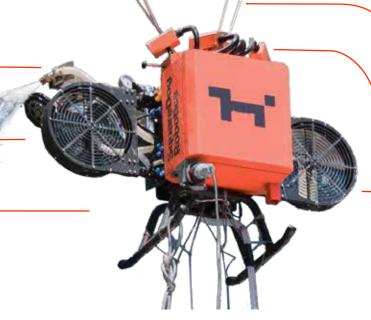
Safety features

- Anti-twinning system
- Dual steel wire
- Remote emergency stop
